The Dowrie Works

An Investigatory Report
By Angus Clean Environments

An investigatory report written by Angus Clean Environments (ACE)

Report on the Proposed Extension to Rock Armour Coastal Protection at Dowrie Bitumen Works, Elliot, Arbroath. NGR 361294, 738161

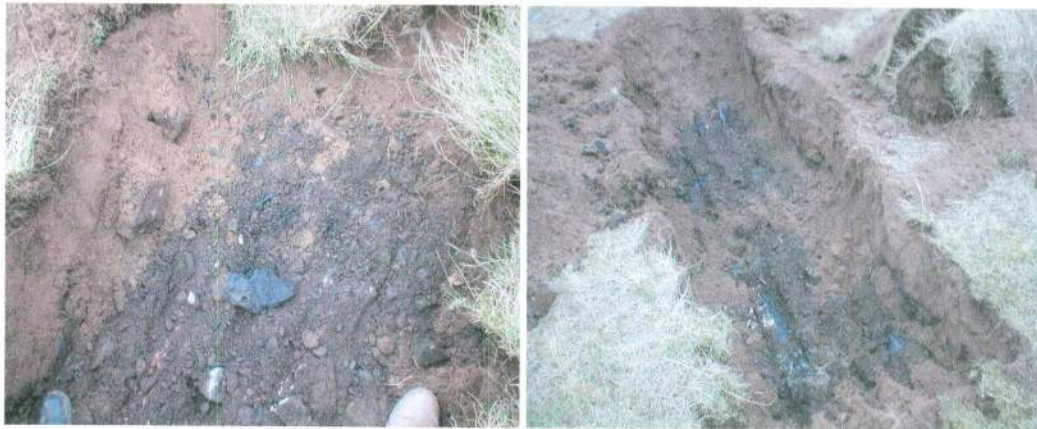
The bitumen waste was black in colour and mixed with brick, concrete and metal fragments (see photographs below).

In all cases the bitumen waste identified in all the trial holes was very hard and could not be excavated, therefore an accurate assessment of the depth of waste materials present could not be undertaken.

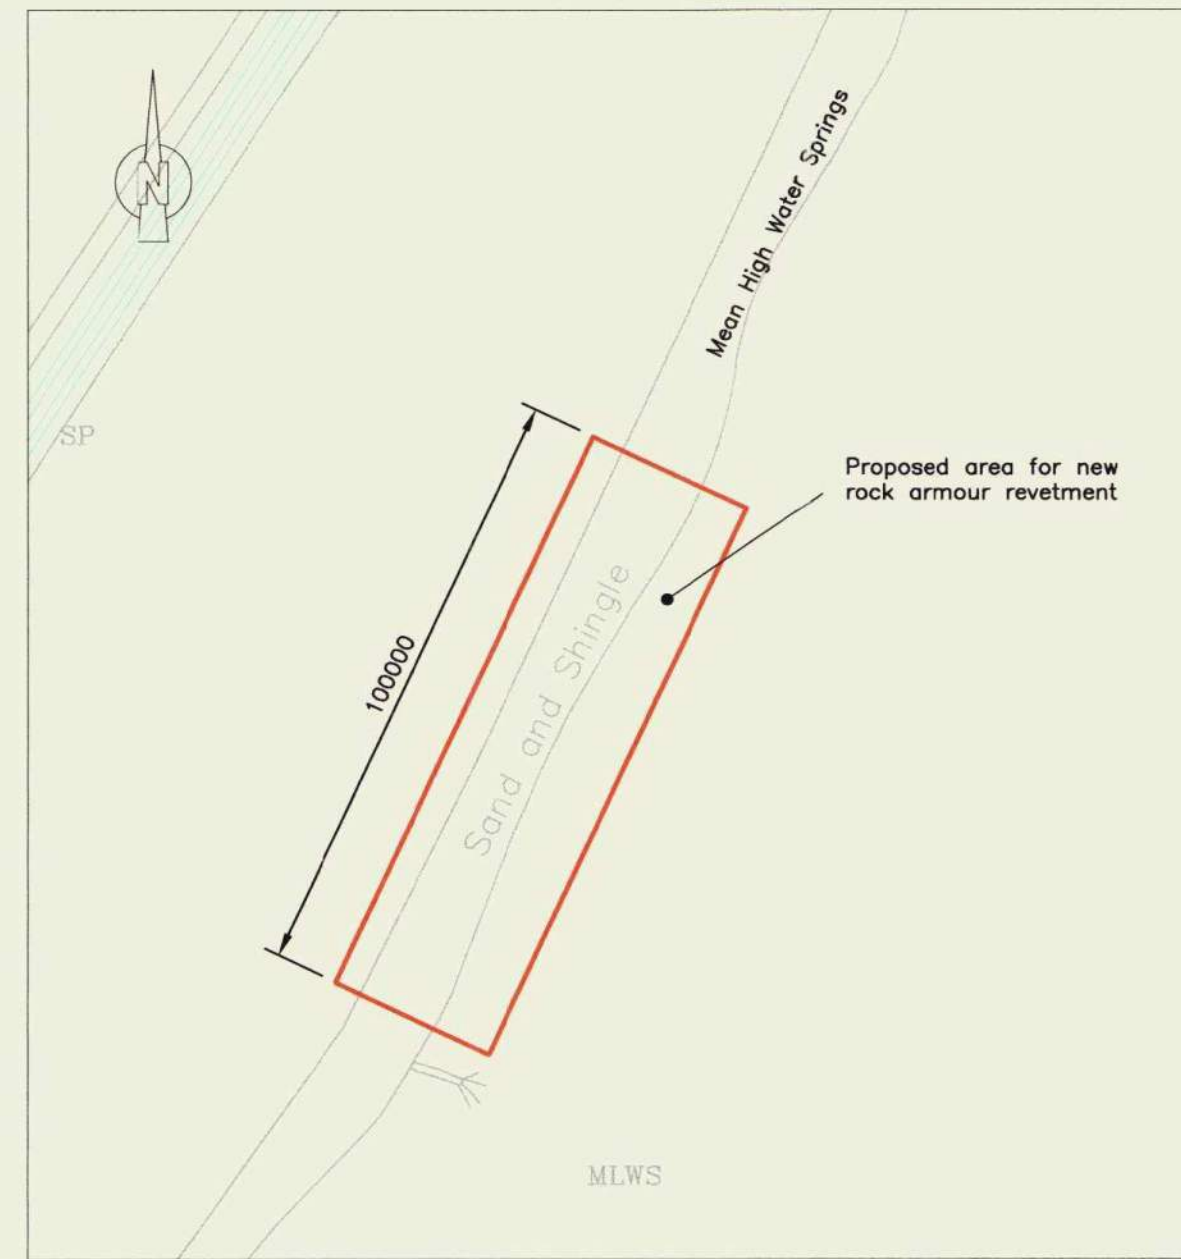
Site Plan Scale 1:1250

Carry out repairs and maintenance works to the existing defences and also extend the existing rock armour revetment a further 100m to prevent further erosion of the dunes and exposure of bitumen deposits from the former Dowrie Bitumen Works.
